EAST PALESTINE TRAIN DERAILMENT AND CONTROLLED BURN: ENVIRONMENTAL DATA REVIEW

October 2023

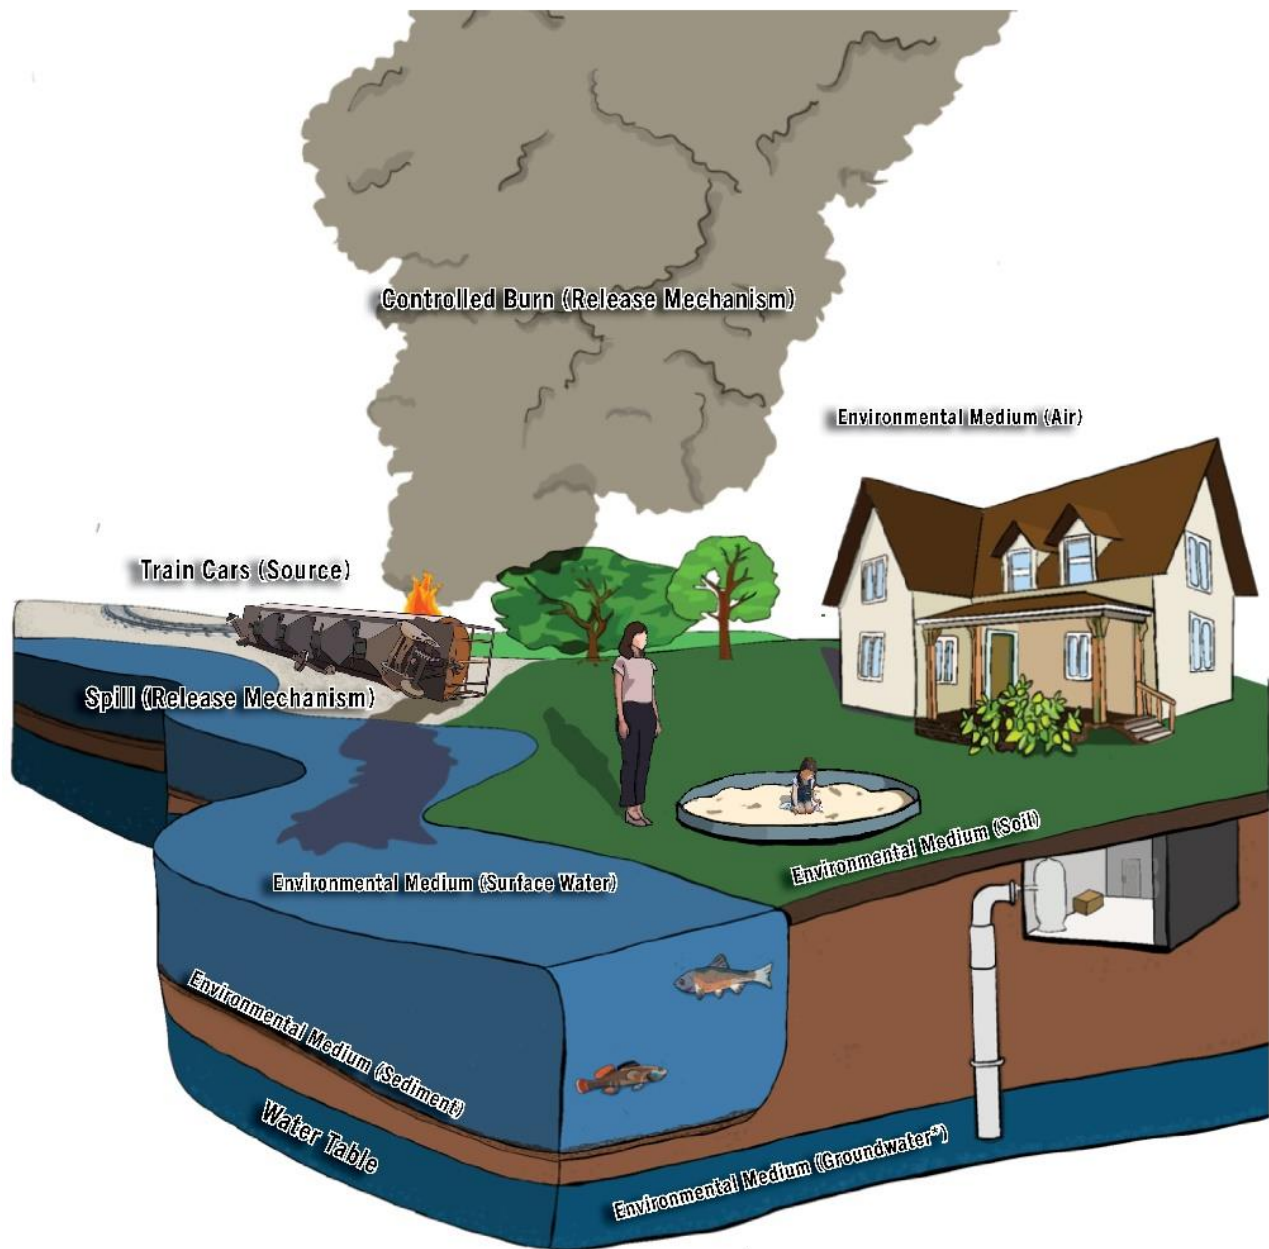
Figure 2. Conceptual Site Model.

These questions focus on understanding if all possible impacts caused by the train derailment and controlled burn have been sufficiently addressed. To answer these questions, TASC used a Conceptual Site Model (CSM) approach (see Figure 2) to track the completeness of the sampling. To determine exposure and impacts to human health, each piece of the CSM is evaluated as follows:

Exposure Pathways: The CSM shows the possible ways that people could be exposed to the contamination resulting from the train derailment and controlled burn. East Palestine residents and officials have identified specific potential pathways: exposure to soils in East Palestine City Park and exposure to swimming pools that may have been impacted by chemical fallout from the controlled burn. Understanding the exposure pathways helps to determine if enough representative samples have been collected for each affected media.

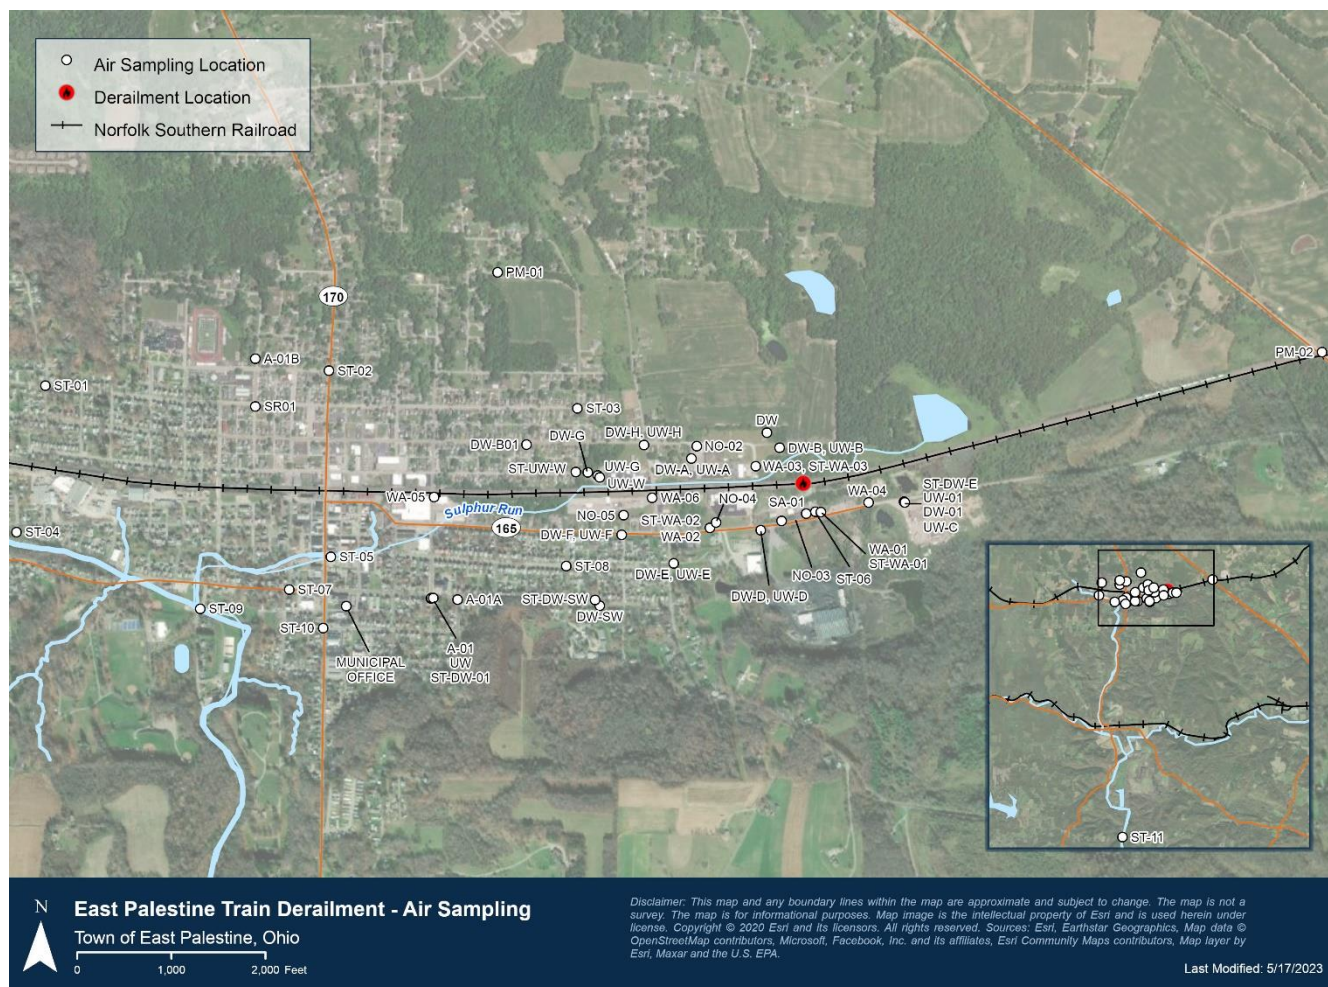
Figure 4. Air Sampling Locations in and around East Palestine.

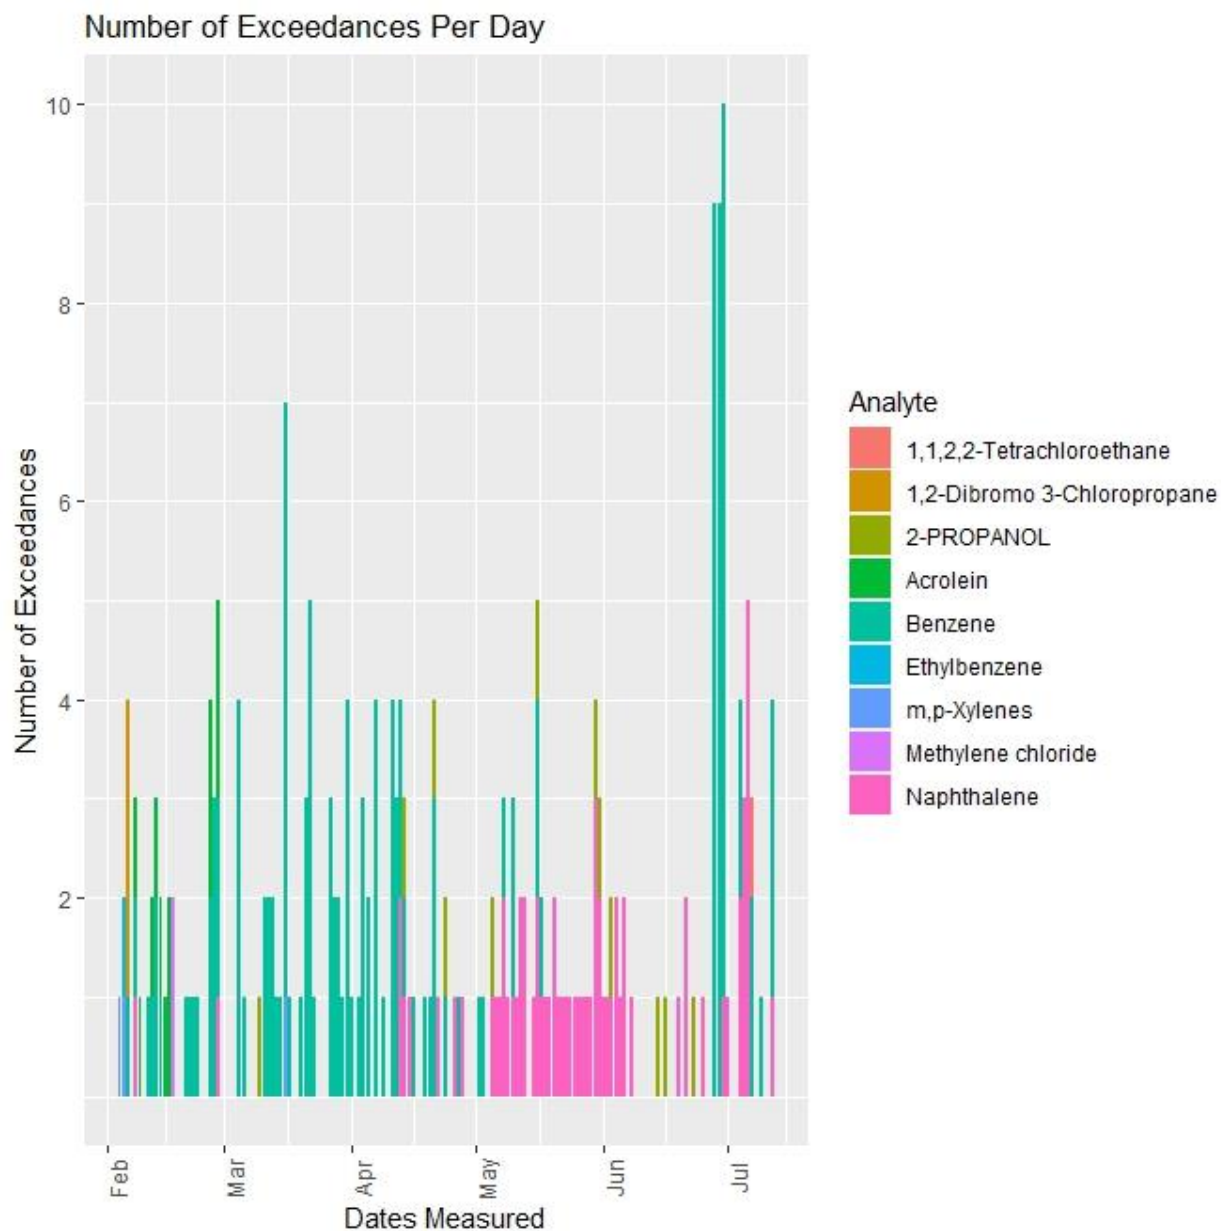
Figure 5. Air Sampling: Detected Chemicals that Exceed Levels Protective of Human Health, by Location.
