EAST PALESTINE TRAIN DERAILMENT AND CONTROLLED BURN ENVIRONMENTAL DATA REVIEW

COMMUNITY WEBINAR
DECEMBER 2023

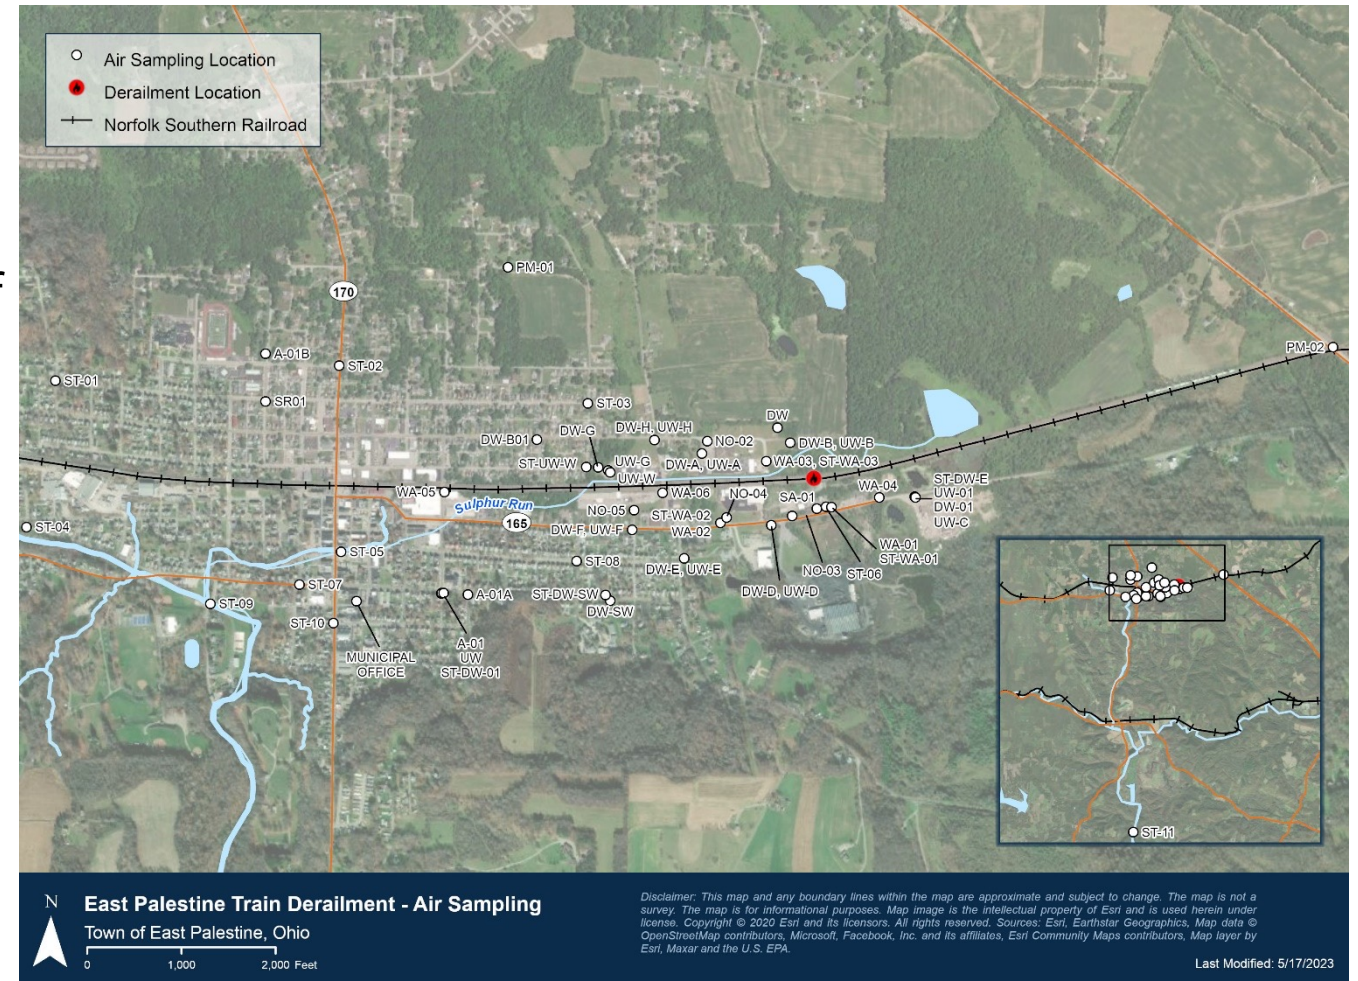
- Air is sampled and monitored using a variety of methods
- Results show volatile organic compounds (VOCs) detected above levels protective of human health on dates during the controlled burn and cleanup efforts; these samples are from locations near the derailment
- Monitoring of air using continuous and roaming methods identified some air quality concerns
- These potential impacts (poor air quality) are often short-term (hours in length) and occur in areas near the derailment

Air sampling locations in and around East Palestine

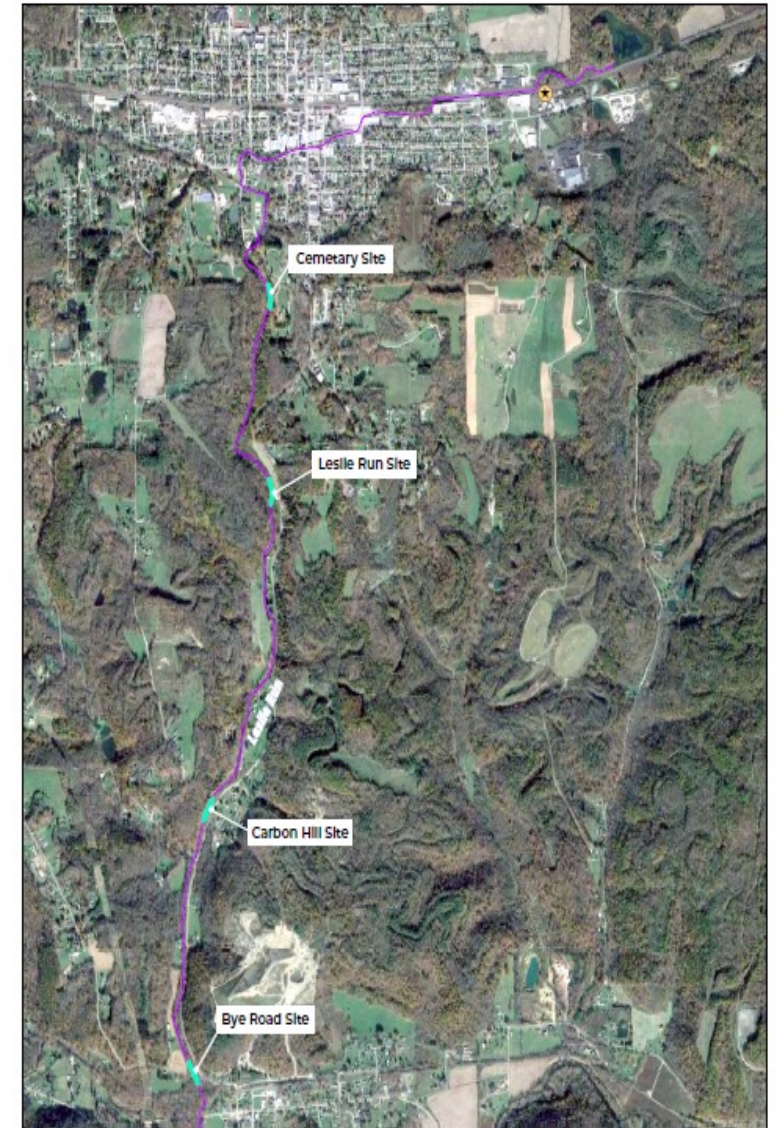
Aquatic Species Collection Sites

- Ohio Department of Natural Resources mobilized immediately after the derailment to monitor aquatic life in Sulphur Run and Leslie Run
- Ohio EPA personnel routinely monitor the Little Beaver Creek watershed (which includes Sulphur Run, Leslie Run and streams downstream of these streams) to measure surface water quality and aquatic health (map provided in surface water discussion)
