EAST PALESTINE TRAIN DERAILMENT AND CONTROLLED BURN:

ENVIRONMENTAL DATA REVIEW UPDATE AND INDEPENDENT STUDIES REVIEW

COMMUNITY WEBINAR SEPTEMBER 2024

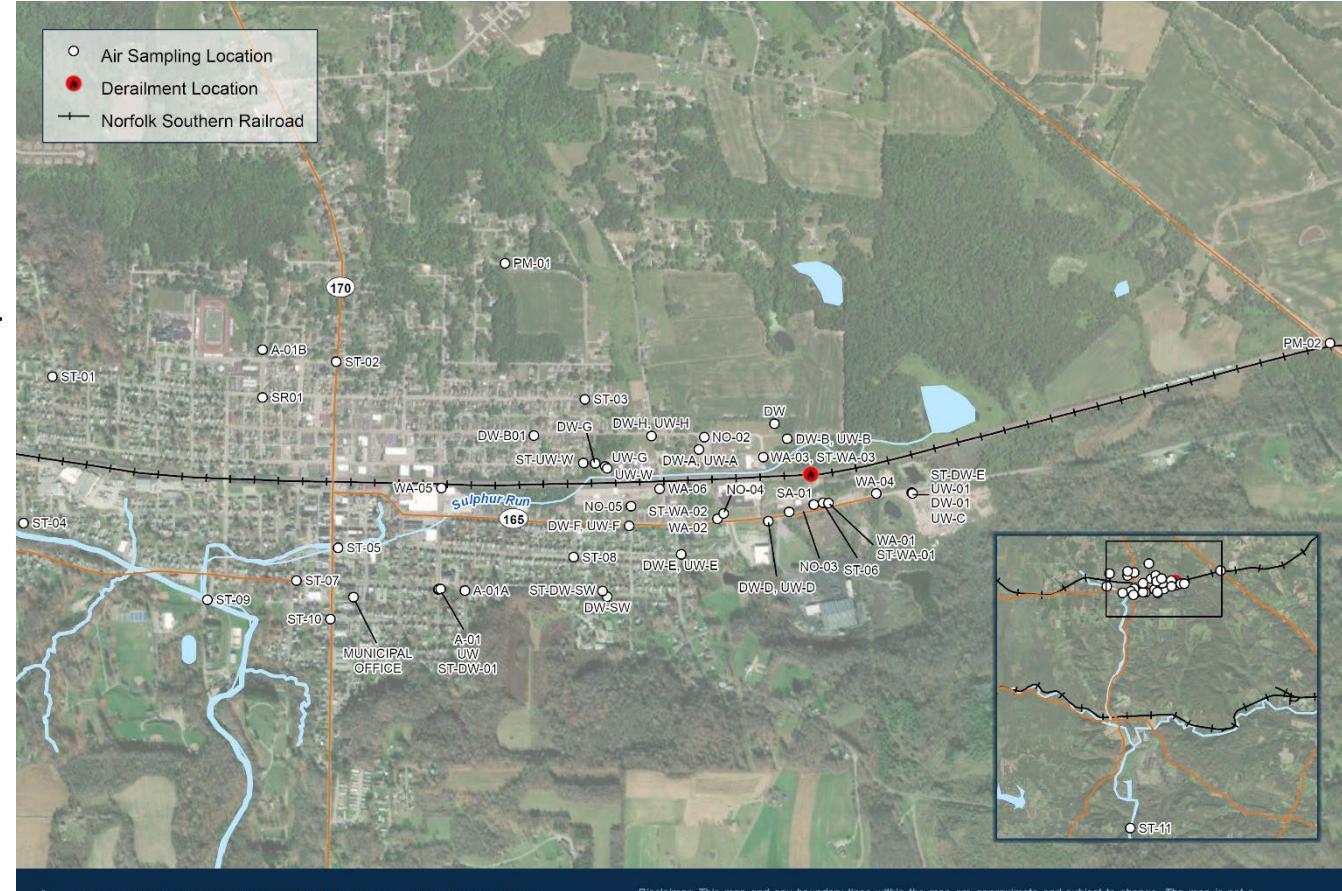
Air sampling locations in and around East Palestine

East Palestine Train Derailment - Air Sampling Town of East Palestine, Ohio isclaimer: This map and any boundary lines within the map are approximate and subject to change. The map is not a urvey. The map is for informational purposes. Map image is the intelectual property of Ean and is used herein under rease. Copyright 0 2020 Est and its licensors. All rights reasoured, Sources Est, Earthstar Goorgankics, Map date @ penStrotkApt contributors, Microsoft, Facebook, Inc. and its affiliates, Est Community Maps contributors, Map layer by al, Maxar and the U.S. EPA.

- Air is sampled and monitored using a variety of methods and has been ongoing since the derailment
- Results show volatile organic compounds (VOCs) detected above levels protective of human health on dates during the controlled burn and cleanup efforts; these samples are from locations near the derailment
- Monitoring of air using continuous and roaming methods identified some air quality concerns
- These potential impacts (poor air quality) were often short-term (hours in length) and occurred in areas near the derailment

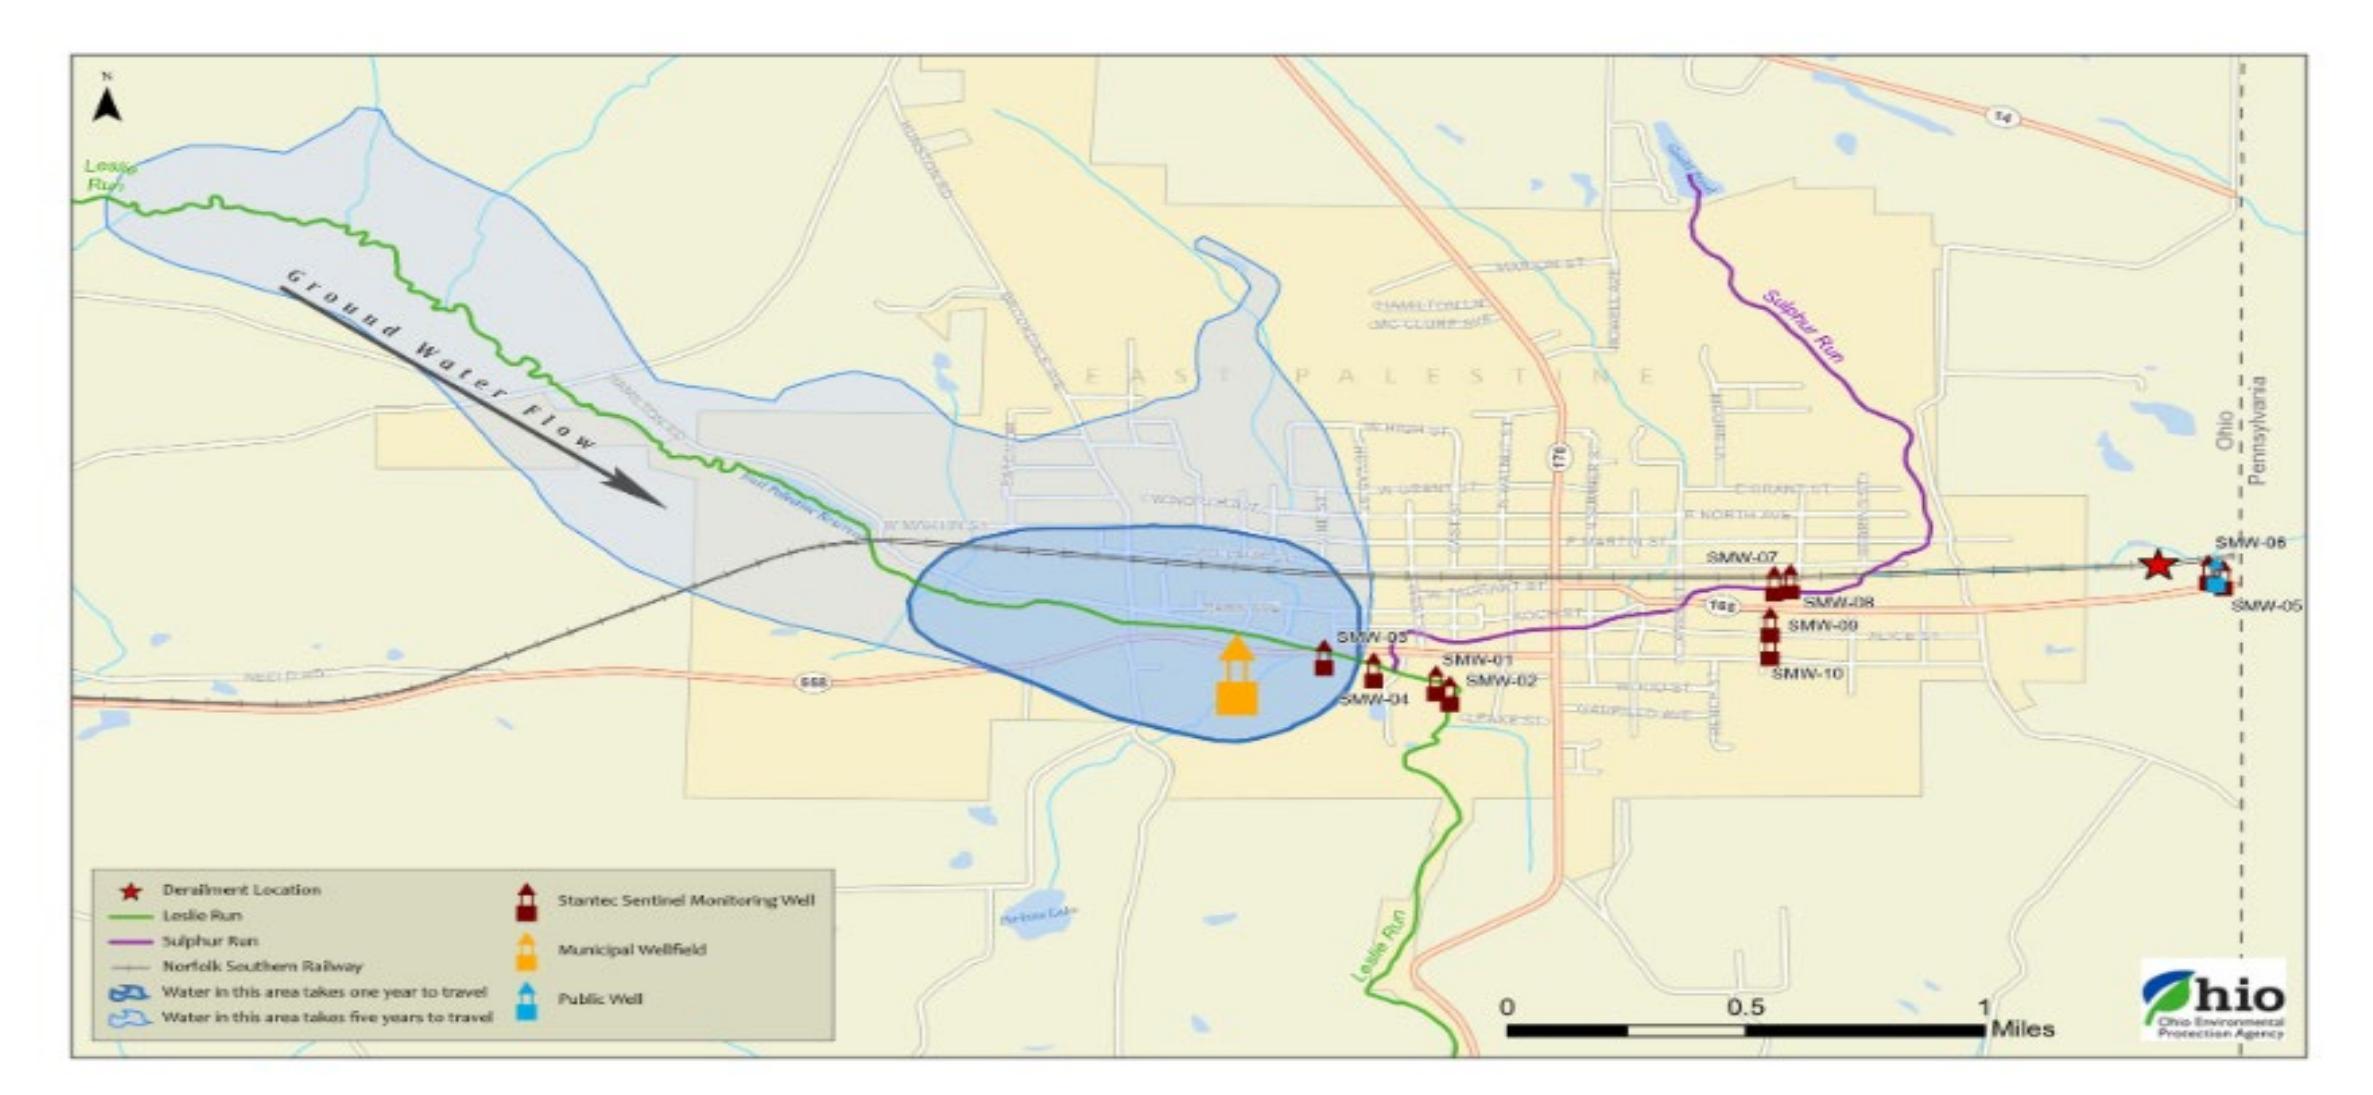
OHIO EPA MAP OF GROUNDWATER FLOW AND MONITORING WELLS AT THE TIME OF THE INITIAL TASC ENVIRONMENTAL REVIEW

East Palestine Ground Water Source and Monitoring Wells

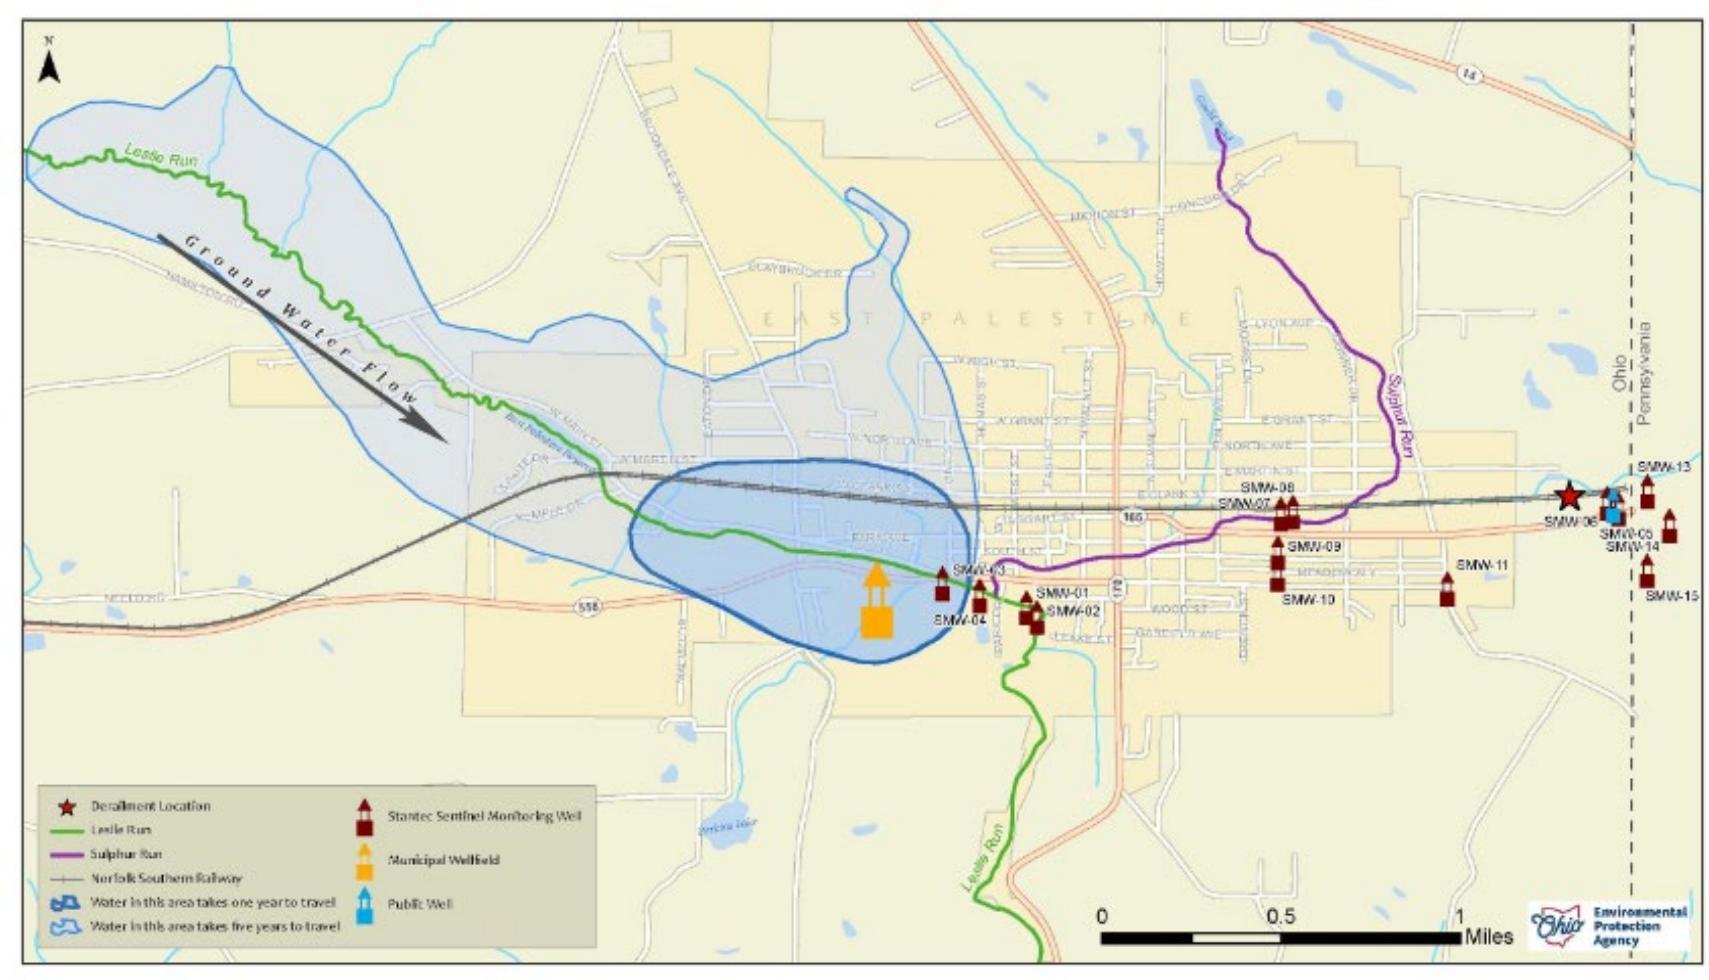
Monitoring wells currently in place

The main differences are:

- Additional wells installed to intercept the groundwater flow path, and
- Additional wells installed to test all possible flow paths from the derailment location

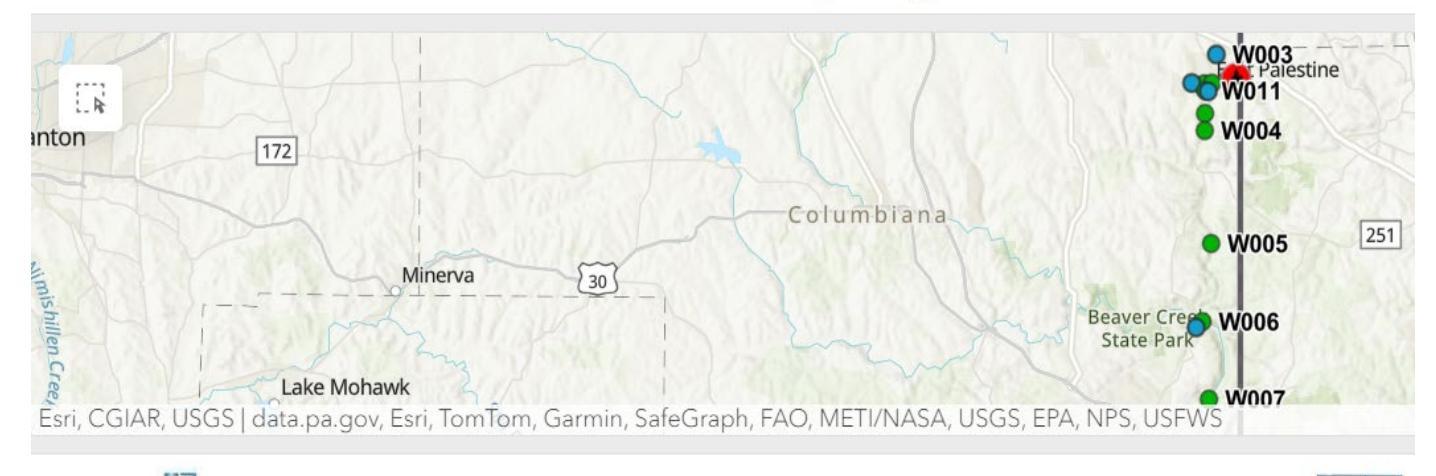
East Palestine Surface Water Sampling

- U.S. EPA's database contains results from 16 samples taken from 13 locations gathered from the beginning of the emergency response (from February 4 through February 14, 2023)
- TASC summarized these results in its initial report-Ohio EPA
- Ohio EPA collects surface water samples from 20 locations beginning at the derailment site in East Palestine and progressing downstream to the Ohio River
- The agency evaluates water quality, sediment quality, bacteria, stream habitat, and biology (fish and insects)
- Results indicate that stream water quality is close to pre-derailment conditions

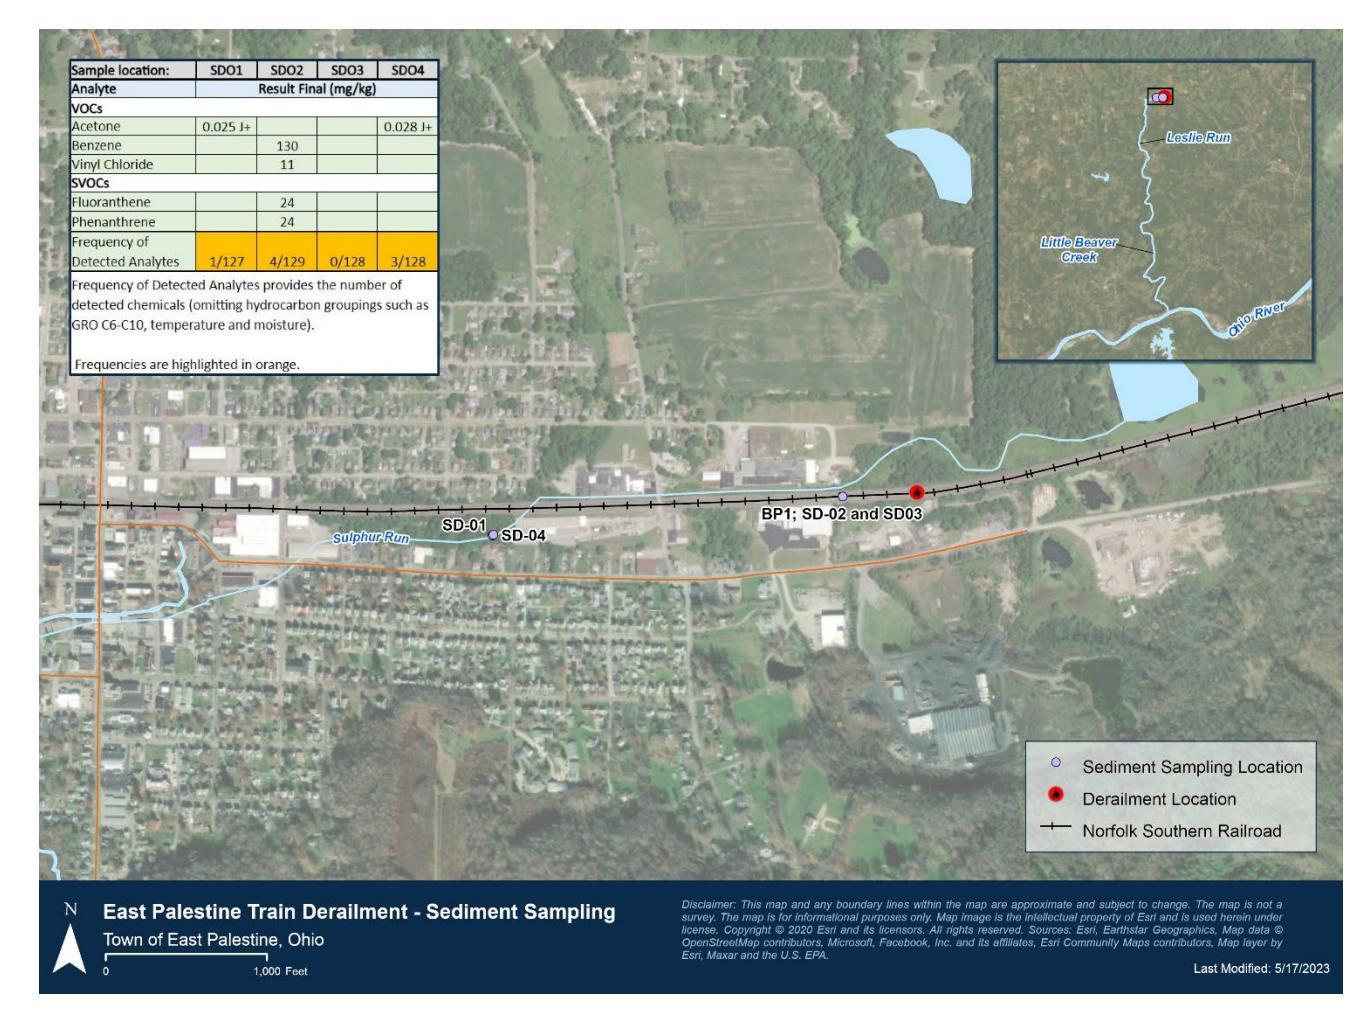
Sediment sampling locations and results

- U.S. EPA collected sediment samples on February 10, 2023, shortly after the derailment
- Data reflects conditions prior to cleanup actions
- The initial results showed that most of the contamination was limited to the derailment area

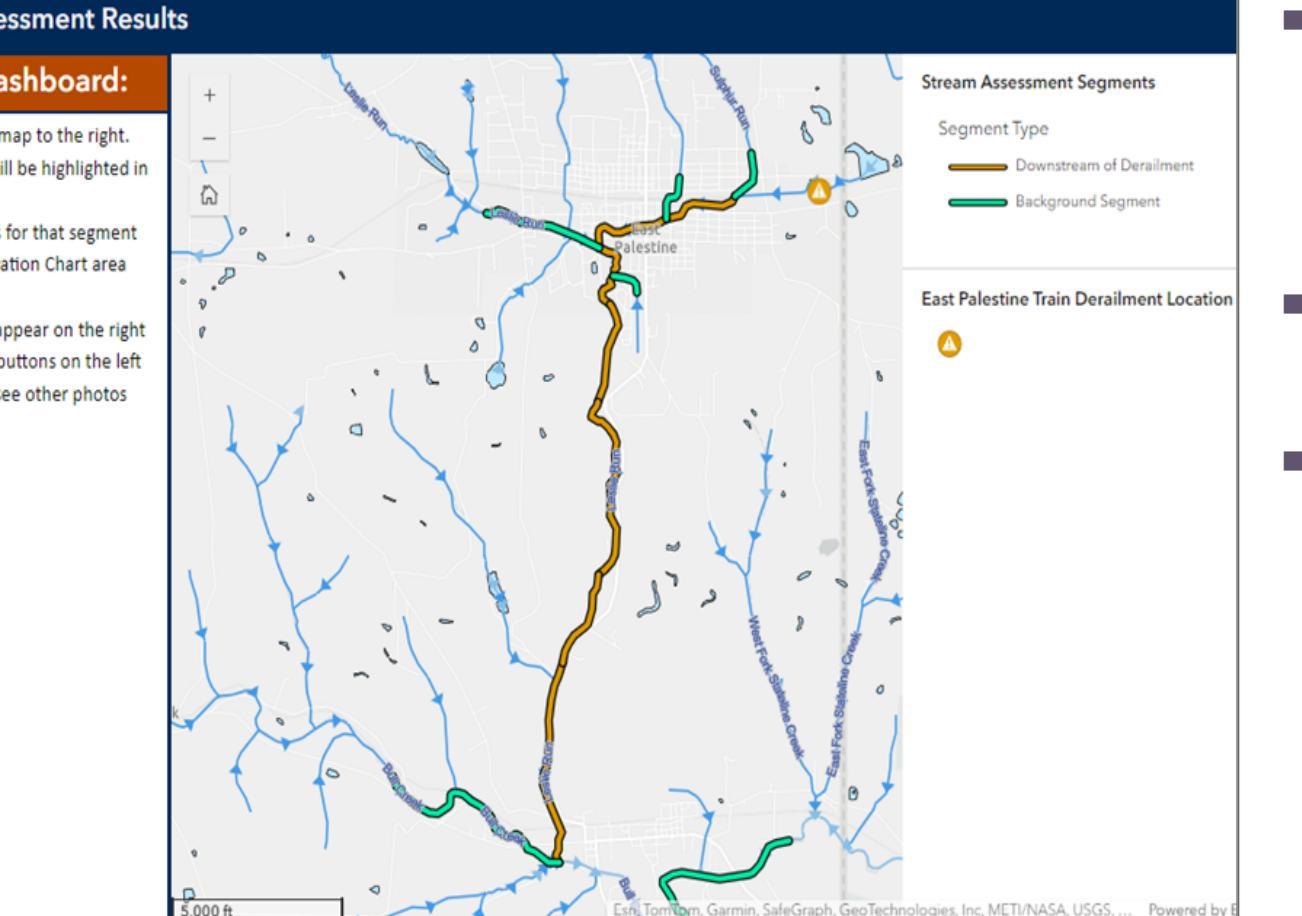
Figure 1. Screenshot of U.S. EPA's East Palestine Derailment Qualitative Sheen Assessment Dashboard

- In Leslie Run, 59% of locations had some sheen, compared to 66% of locations in Sulphur Run
- In background locations, 92% of areas had no sheen
- U.S. EPA's East Palestine Derailment Qualitative Sheen Assessment Dashboard provides a breakdown of the sheen results observed in each segment, as well as photos from different points along the segment
